Gurnee Police Department Memorandum

SUBJECT: Follow-up Evaluation Report (Three Year)

DATE:10/5/2018

The Village of Gurnee is required to provide a follow-up evaluation report to the Illinois Department of Transportation for the intersection(s) of Route 41 & Delany, Route 132 & Route 21, Route 132 & Dilleys and Route 132 & Hunt Club Road one year after the installation of a RLR Camera System.

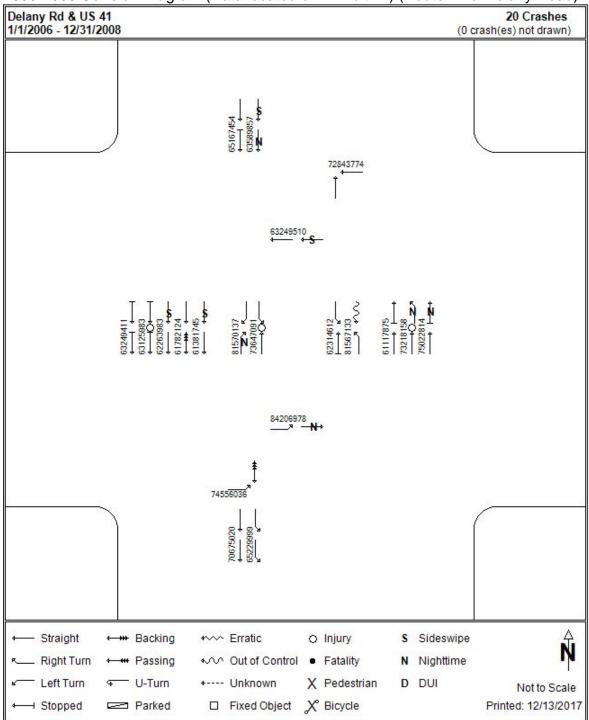
2006-2008 Collision Diagram (Data located on Exhibit #1) (Route 41 & Delany Road)

The data from Route 41 & Delany Road has seen an increase in traffic crashes. It does suggest two hazardous actions are contributing to the increase: following too closely/failure to yield. There were (8) following too closely an (33) failure to yield.

There are two recommendations. First, continue to analyze the intersection(s) crash data over the next three years to monitor post photo enforcement data. Second; protect the left turn lanes for east and westbound traffic at Route 41 & Delany Road to reduce the traffic crashes that are a result of failure to yield while turning left.

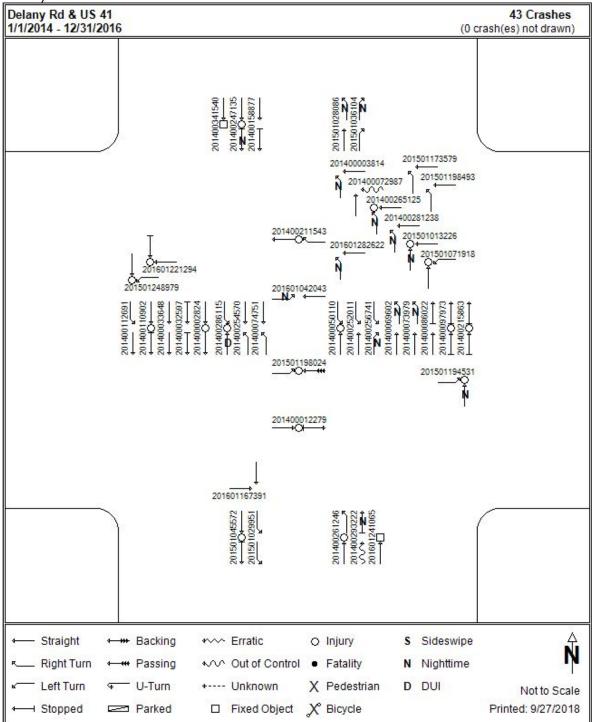
2014-2016 Collision Diagram (Data located on Exhibit #5) (Route 41 & Delany Road)

The post camera system crash data (Exhibits #2-5) show an increase in crashes at one intersection as compared to Exhibit #1, Route 41 & Delany Road.
