DEMOLITION SERVICES FOR 4606 & 4625 OLD GRAND AVENUE

"Demolition Services for 4606 & 4625 Old Grand Avenue"

Asbestos Survey

4609-4617 and 4625 Old Grand Ave., Gurnee, IL

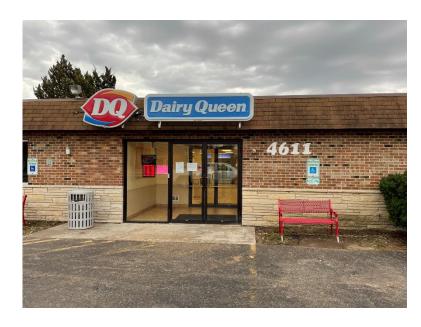
Photo No. 1

Sample No. 1 - A, B, C

Description: Concrete Block & Mortar

Color: Grey

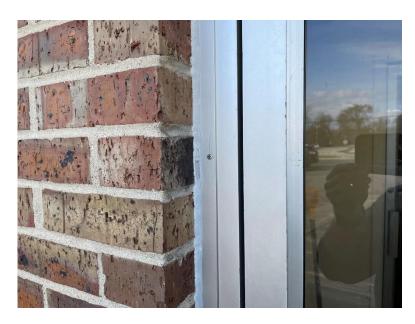
Photo No. 3

Sample No. 3 – A, B, C, D, E, F, G, H

Description: Exterior Caulk

Color: Multi

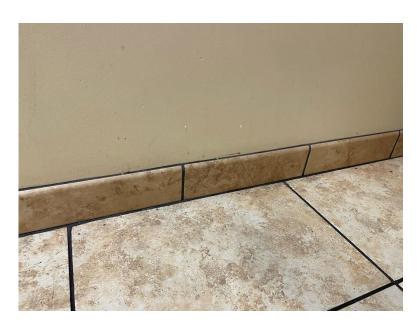
Photo No. 5

Sample No. 5 - A, B, C

Description: 4" Ceramic Base

Color: Tan/Black

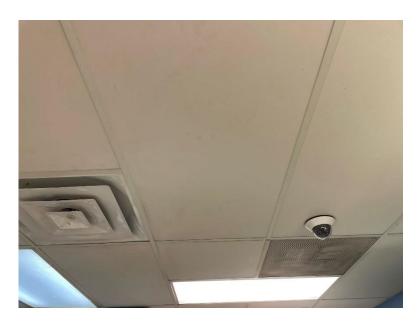
Photo No. 7

Sample No. 7 - A, B, C

Description: 2' x 4' Lay-In Ceiling Tile

Color: White

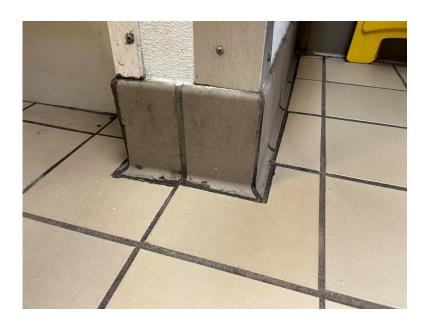
Photo No. 9

Sample No. 9 - A, B, C

Description: Ceramic Flooring, Base, & Grout

Color: Tan/Black

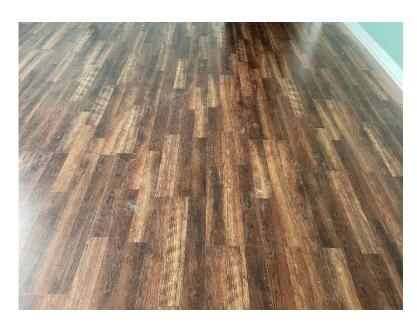
Photo No. 13

Sample No. 13 - A, B, C

Description: Laminate Flooring

Color: Wood Pattern

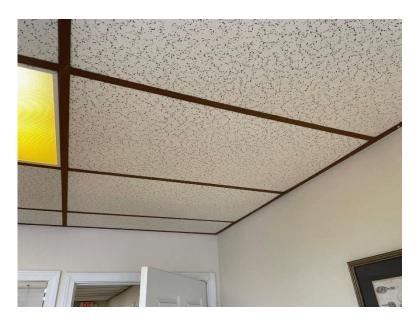
Photo No. 17

Sample No. 17 – A, B, C

Description: 2' x 4' Lay-In Ceiling Tile

Color: White

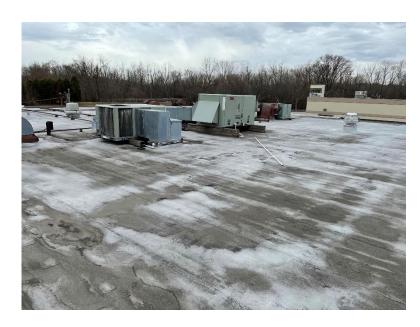
Photo No. 21

Sample No. 21 - A, B, C

Description: Roofing Materials

Color: Black

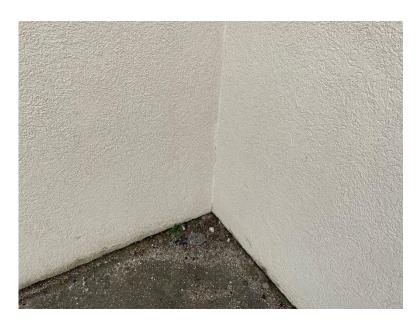
Photo No. 23

Sample No. 23 – A

Description: Dryvit Siding

Color: Tan/White

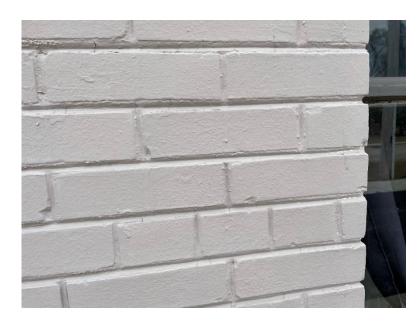
Photo No. 25

Sample No. 25 – A, B, C

Description: Brick & Mortar

Color: Grey/White

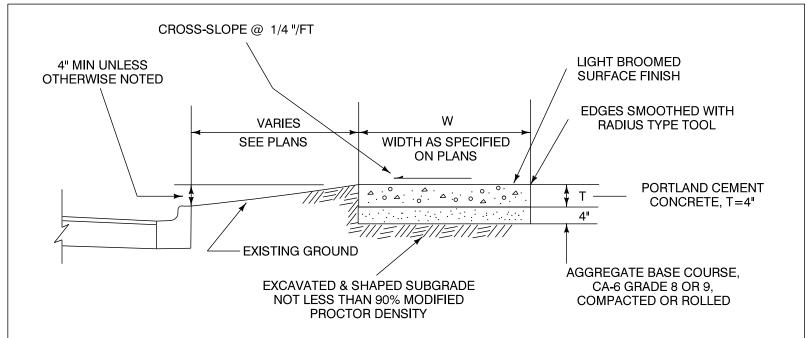
Appendix C

- At locations where sidewalk is subjected to wheel traffic and/or constructed across access drive entrances, the P.C.C. Sidewalk Section shall be thickened to 6" across the width of the driveway.
- 2. Placing, finishing and curing of P.C.C. Sidewalk shall meet the requirements of Sections 424 & 1020 of the Standard Specifications for Road and Bridge Construction. Use Class SI IDOT approved mix design approved by the Engineer.
- Slab or panel contraction (control) joints shall be as follows:
